SURVEY OF LONG-TERM DURABILITY OF FIBERGLASS-REINFORCED
PLASTIC STRUCTURES

DOE/NASA/9549-1
NASA CR-165320
TRS 106

Seymour Lieblein
Technical Report Services

January 1981

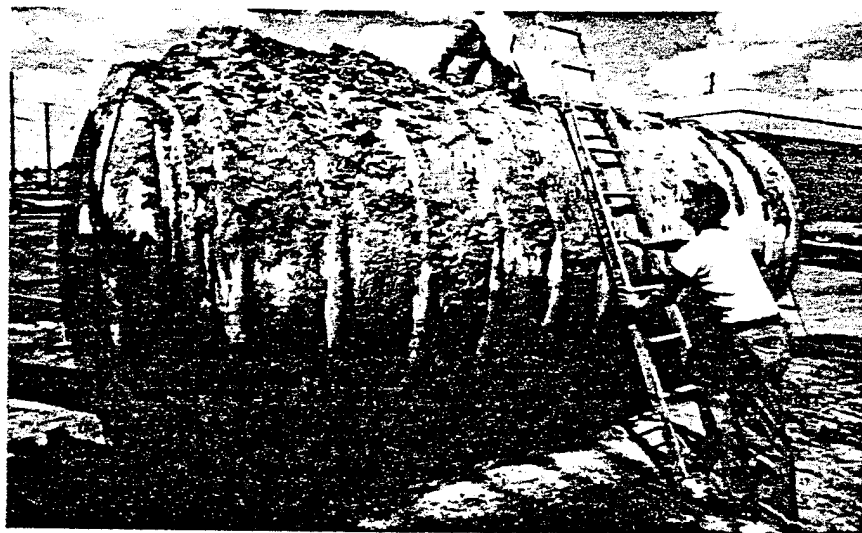
Figure 18. - Filament-wound fiberglass gasoline storage tank unearthed after 12 $\frac{3}{4}$ years of service. (Photo courtesy of Owens-Corning Fiberglas Corp.)

Tank after nearly 13 years. - The second tank, which was installed in Stony Ridge, Ohio, was removed in 1977 after 12 years and 9 months of continuous service (ref. 13). A photograph of the tank after removal is shown in figure 18. The exterior surface of the tank ends and the center joints had a white, somewhat chalky film, which easily scrubbed off with an abrasive cleaner. This surface effect was typical of air-cured fiberglass surfaces exposed to moisture over long periods of time. No areas of cracking or crazing were found on the inner surface.

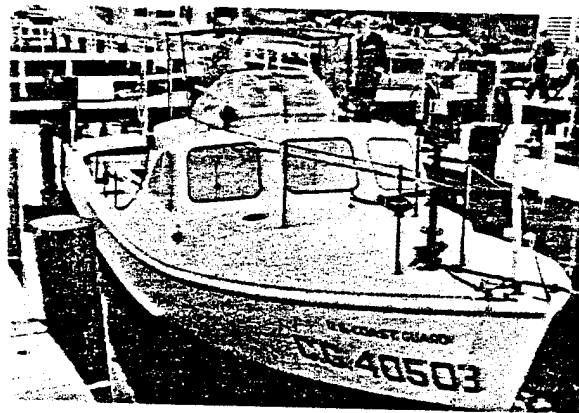
Figure 21. - 40-Foot Coast Guard patrol boat with fiberglass hull. (Photo courtesy of Owens-Corning Fiberglass Corp.)

Forty-foot fiberglass-reinforced plastic patrol boats (fig. 21) were built for the Coast Guard during the early 1950's. The structural configuration consisted of a single skin fiberglass-reinforced plastic hull and cabin. The fiberglass laminates in the hull were fabricated with 10-ounce cloth mat and 1½-ounce chopped strand reinforcements. Materials were E glass and general purpose polyester resin. Average laminate thickness was around 3/4 inch for the bottom shell, and around 3/8 inch for the side shell, deck, and cabin.
